The Cottage at 144 Birmingham Road, Wylde Green

By Alan Howells

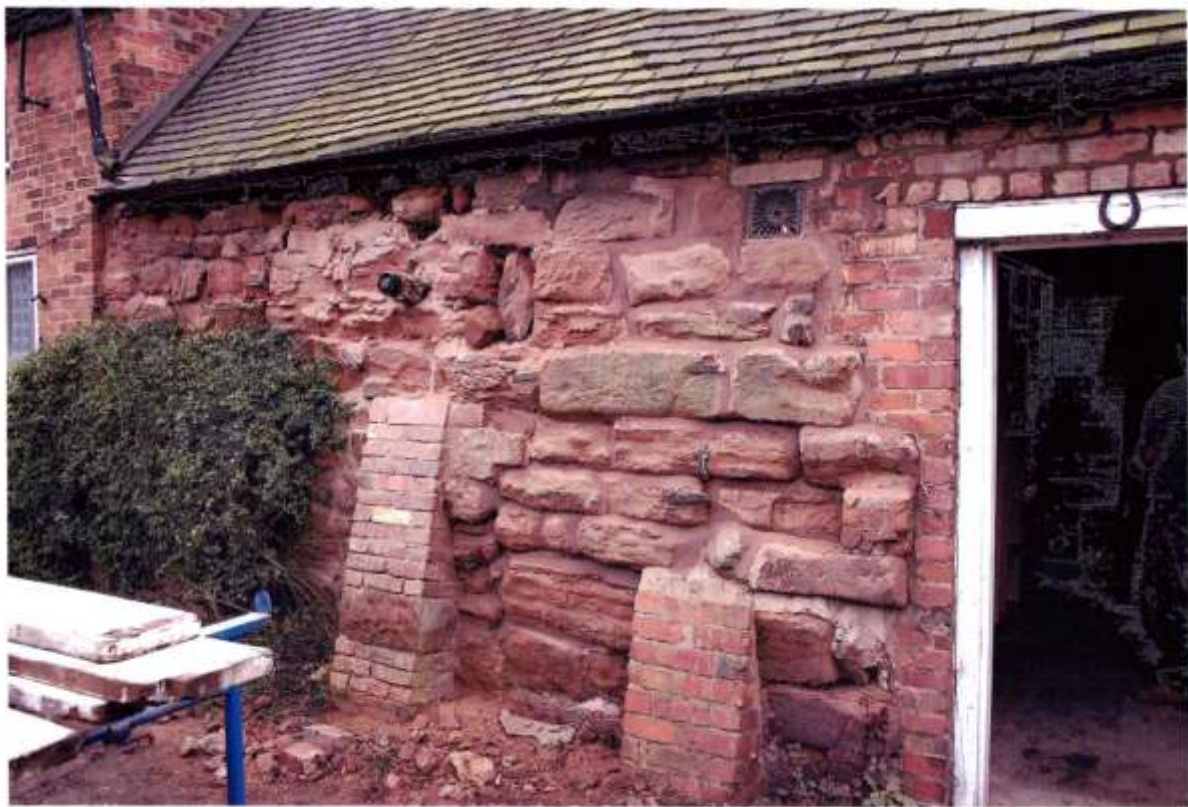
The walls are built of double thickness sandstone blocks with rubble infill in the centre. Such walls were quite adequate to support the heavy oak roof without the need for columns. There were vertical ventilation slots in the upper section of the north wall, a sign that the building had housed farm animals. Some of the sandstone blocks had been replaced with brickwork, notably round the doorway, replacing a former lintel, and there were two brick buttresses of early twentieth century date. The gable end facing west had had an inner leaf of modern bricks added. During renovation a new window was inserted in the north wall, and a window in the south wall which overlooked the rear yard of the adjacent cottage is now blocked up.

The north wall of the rear barn, before the new window was inserted.

The building at the rear was originally built as an animal byre, with thick stone walls, probably 18th century. There were two small dormer windows with crude shutters giving access to the loft where fodder would have been stored – these were removed early in the twentieth century when the roof was retiled. During renovation two new, larger dormer windows were inserted, double glazed with wooden frames, in approximately the same position.

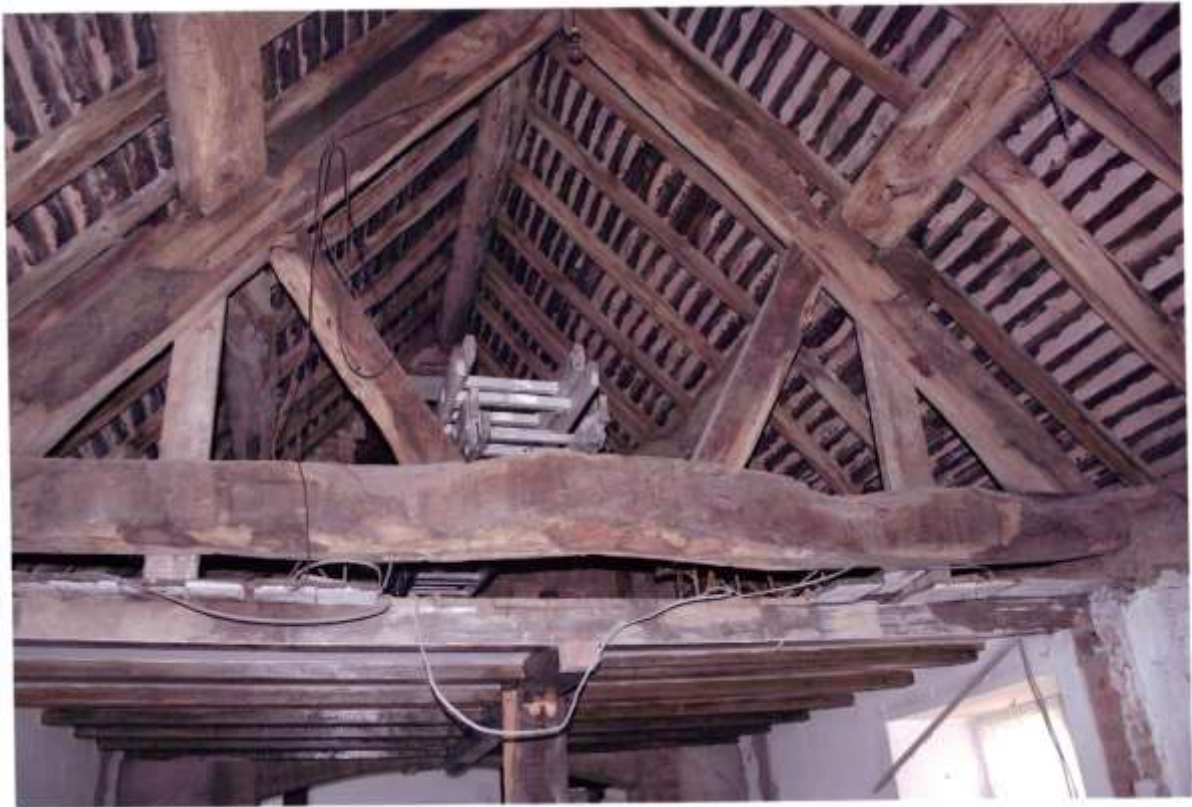
During renovation the roof tiles were removed and replaced, tiles reclaimed from other old buildings being used where necessary. No date markings were found on any tiles, but some bore the maker's name "Whitlock Collier – Coalville". The tiles had already been refitted ,

probably when the dormer windows were removed, they had been mounted on softwood laths with a cement torching.

Roof of the rear barn during renovation

The ends of the large trenched purlins were embedded in the gable end of the cottage to the east and the barn gable to the west. Across the centre of the building the large oak tie beam rests on the oak wall plates and supports the principal rafters into which the purlins are trenched, with struts to the tie beam, all fastened with oak dowels, wedges and square nails, hand made of iron in the 18th century. During renovation the north purlin was moved down to accommodate the new dormer windows the south side purlin was moved up to make room for a new staircase, and the old oak rafters were replaced with treated softwood.
